Stop D Drake (Mountain Valleys)

Flood Hazard in Mountain Valleys

The Big Thompson Flood

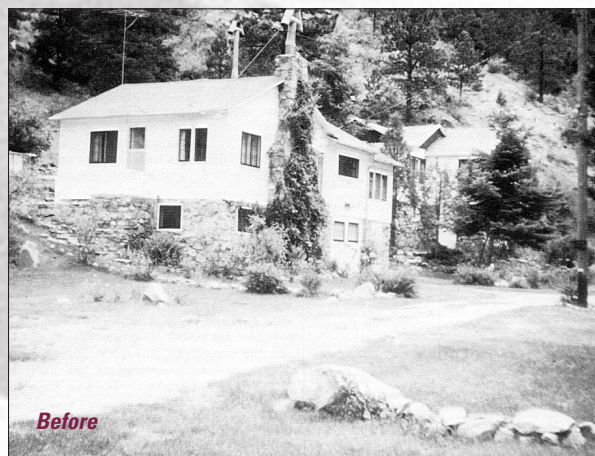
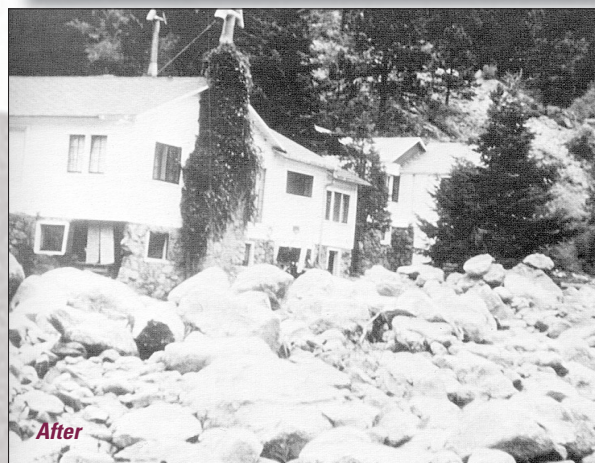
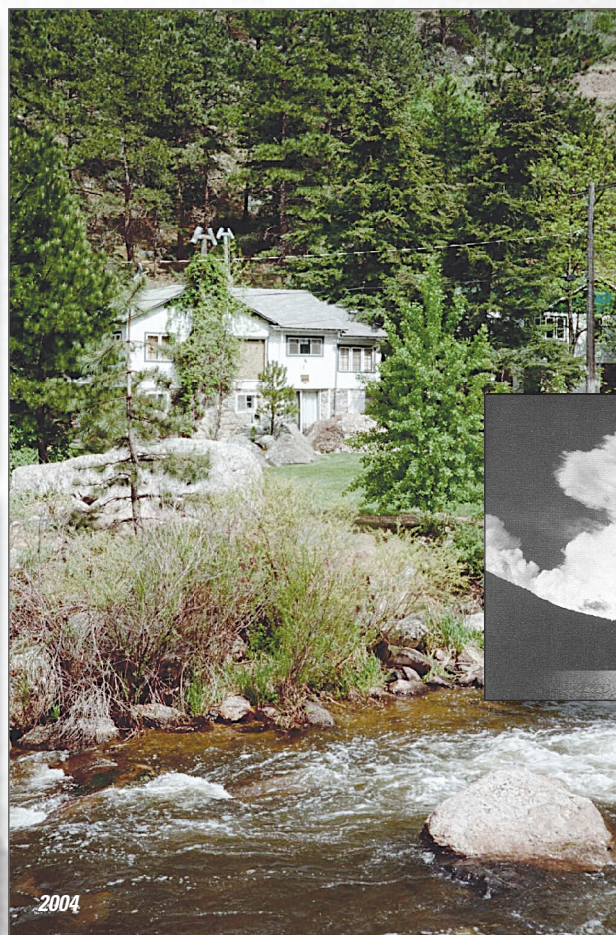
Ground-level photographs of the same Drake house before and after the flood show numerous large boulders deposited during the 1976 event. Comparative photograph from 2004 shows that flood effects are almost invisible after less than 30 years. Black and white images from U.S. Geological Survey (1979).

Before

After

2004

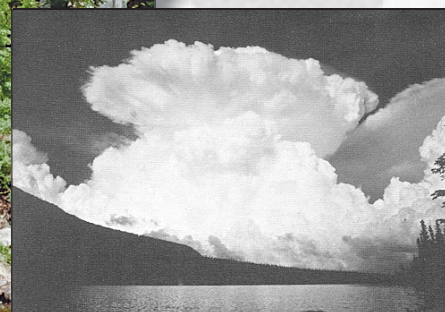
July 31, 1976, photograph of large thundercloud over the Big Thompson drainage. Image from U.S. Geological Survey (1979).

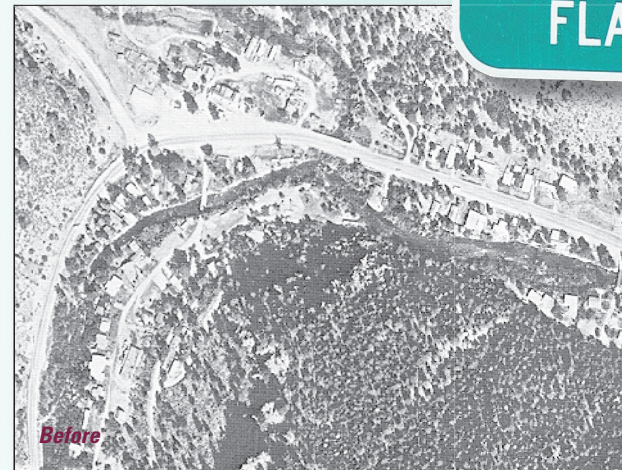
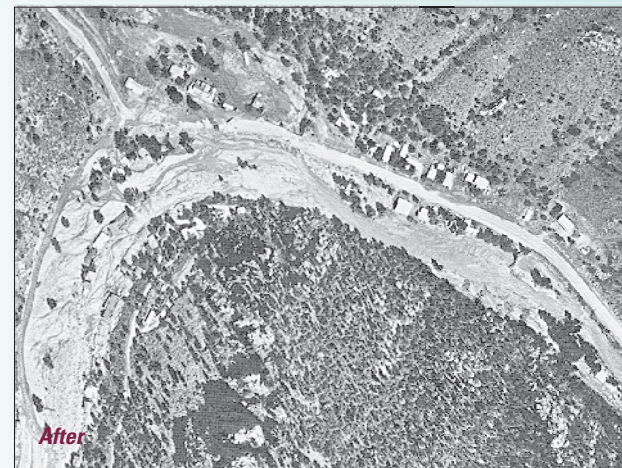
(Below) Aerial photographs taken before and immediately after the flood show the extent of change in the floodplain. Images from U.S. Geological Survey (1979). ▼

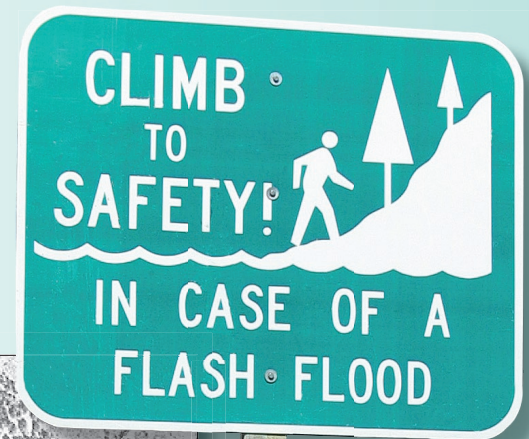
(Right) Warning signs were installed in most Colorado canyons following the Big Thompson flood. ►

Official evaluations following the tragic event determined that many deaths in the canyon could have been avoided. Many who died probably could have survived if they had abandoned their vehicles and climbed to safety. It has been many years since clean-up and reconstruction in the canyon, and vegetation has regrown—the geologic effects of the flood are now hard to see. Roadside warning signs (“CLIMB TO SAFETY! IN CASE OF A FLASH FLOOD”) are some of the few visual reminders of this major flood.
